Uniform Mitigation Verification Inspection Form

Inspection Date: 04-26-2022		
Owner Information		
Owner Name: (BHC, Inc., A Condominium Association) Beacon House Tower One Condominium Association		Contact Person:
Address: East Building - 2170 Gulf Shore Boulevard N.		Home Phone:
City: Naples	Zip: 34102	Work Phone:
County: Collier		Cell Phone:
Insurance Company:		Policy #:
Year of Home: 1965	# of Stories: 7	Email:

BUILDING TYPE II AND III MITIGATION INSPECTION FORM

(BHC, Inc., A Condominium Association) Beacon House Tower One Condominium Association
East Building – 2170 Gulf Shore Boulevard N., Naples, FL 34102
04-26-2022

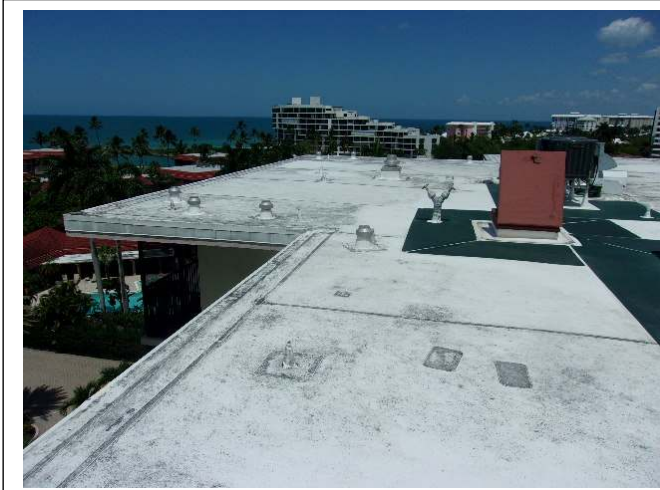
ROOF COVERING SYSTEM – The roof covering system is fully functional with no observable deficiencies. The mechanical devices appear to be secured in a manner to resist high wind events.

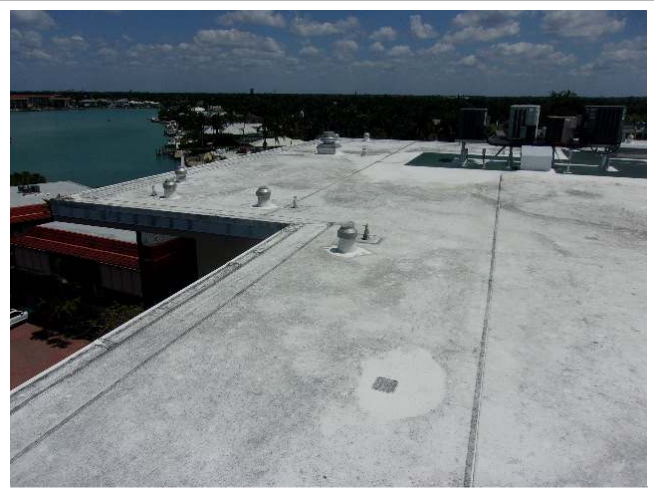
ROOF COVERING SYSTEM – The roof covering system is fully functional with no observable deficiencies. The mechanical devices appear to be secured in a manner to resist high wind events.

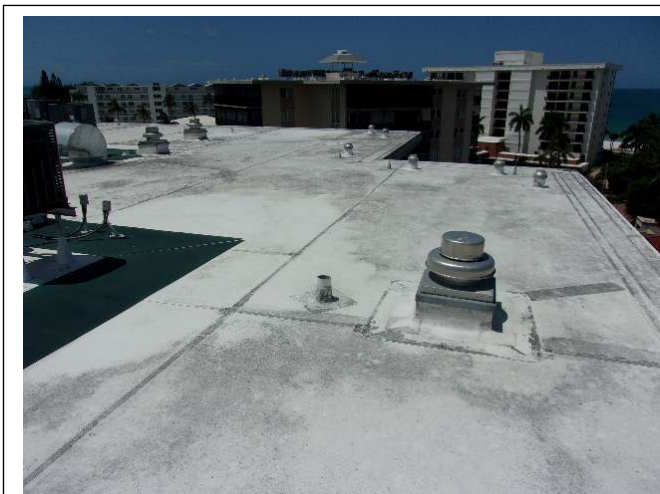
ROOF COVERING SYSTEM – The roof covering system is fully functional with no observable deficiencies. The mechanical devices appear to be secured in a manner to resist high wind events.

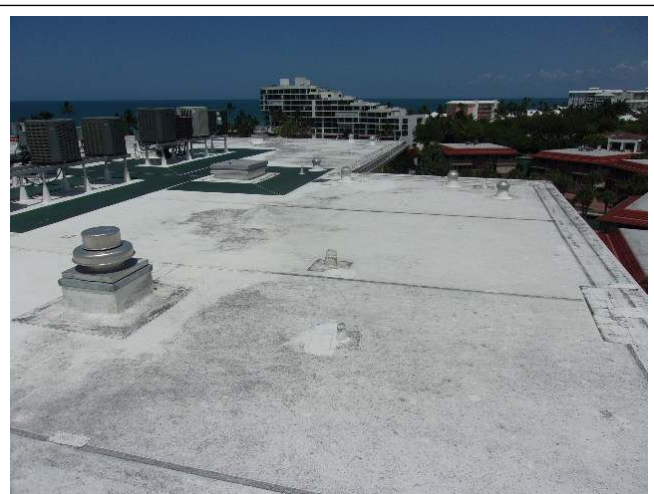
ROOF COVERING SYSTEM – The roof covering system is fully functional with no observable deficiencies. The mechanical devices appear to be secured in a manner to resist high wind events.

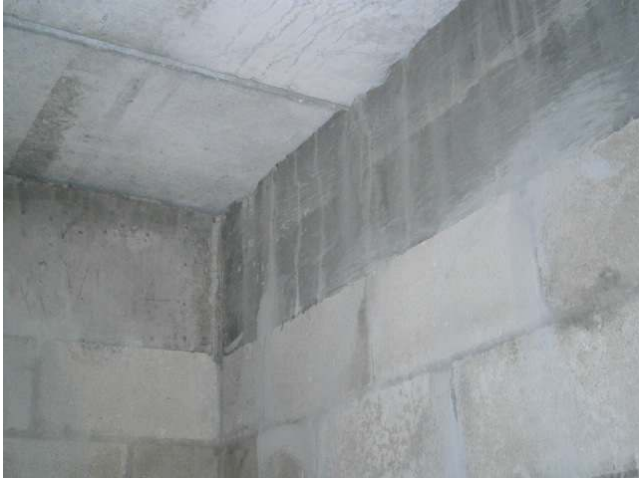
REINFORCED CONCRETE ROOF DECK ON
REINFORCED CONCRETE WALLS

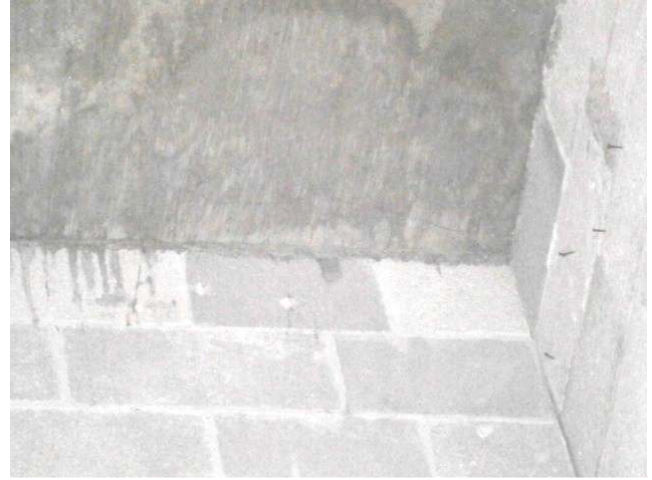
REINFORCED CONCRETE ROOF DECK ON
REINFORCED CONCRETE WALLS

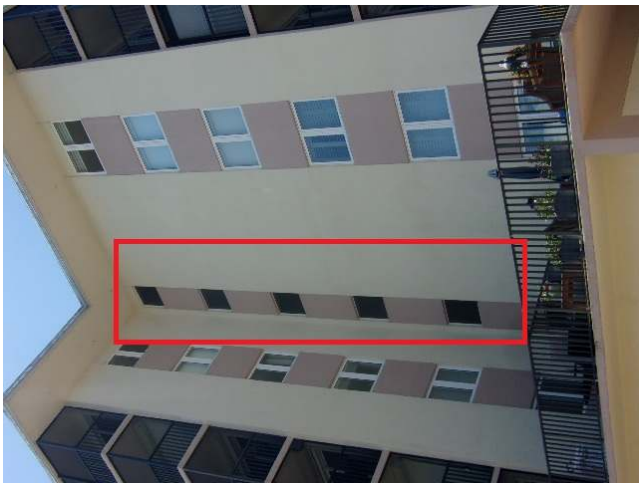
4. Opening Protection **N/A - Some glazed openings are not rated or protected**

OPENING PROTECTION – Although the unit owner window & sliding door openings are large missile rated, the stairwell windows are not rated or protected.

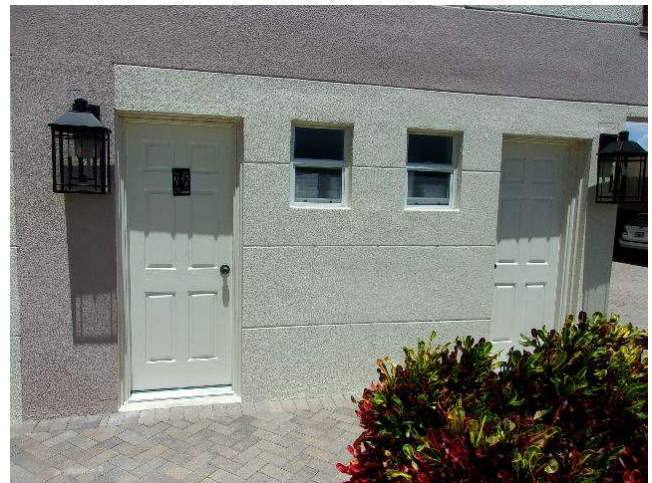
OPENING PROTECTION – The ground level pool bathroom doors are impact rated, but the window units are not rated or protected.

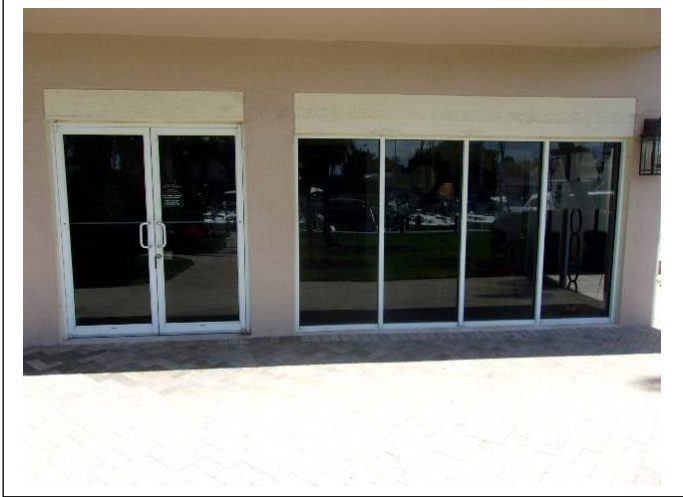
OPENING PROTECTION – The ground level glazed openings are not rated or protected.
