Uniform Mitigation Verification Inspection Form

Inspection Date: 04-26-2022		
Owner Information		
Owner Name: (BHC, Inc., A Condominium Association) Beacon House Tower Two Condominium Association		Contact Person:
Address: West Building - 2170 Gulf Shore Boulevard N.		Home Phone:
City: Naples	Zip: 34102	Work Phone:
County: Collier		Cell Phone:
Insurance Company:		Policy #:
Year of Home: 1968	# of Stories: 8	Email:

BUILDING TYPE II AND III MITIGATION INSPECTION FORM

(BHC, Inc., A Condominium Association) Beacon House Tower Two Condominium Association
West Building – 2170 Gulf Shore Boulevard N., Naples, FL 34102
04-26-2022

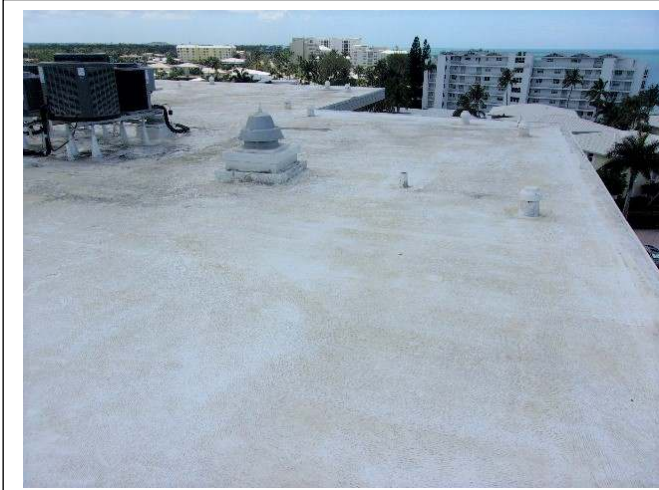
ROOF COVERING SYSTEM – The roof covering system is fully functional with no observable deficiencies. The mechanical devices appear to be secured in a manner to resist high wind events.

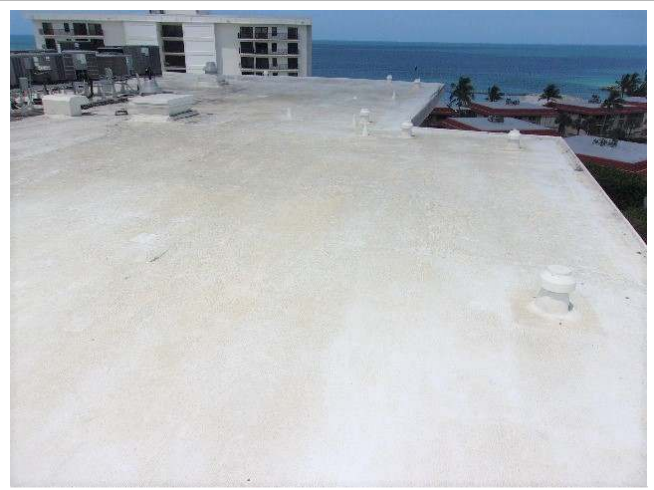
ROOF COVERING SYSTEM – The roof covering system is fully functional with no observable deficiencies. The mechanical devices appear to be secured in a manner to resist high wind events.

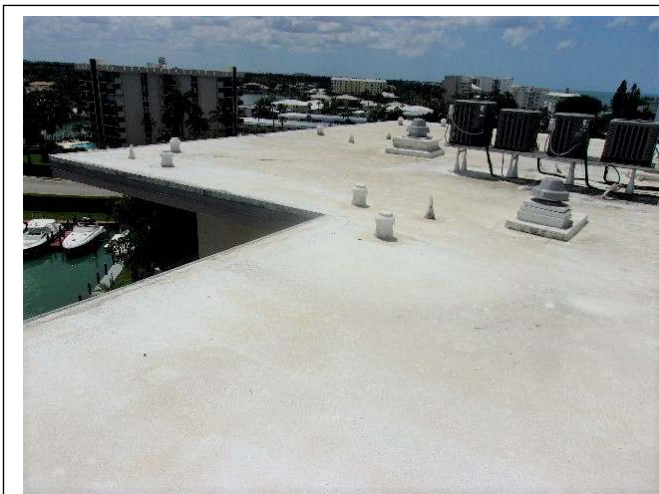
ROOF COVERING SYSTEM – The roof covering system is fully functional with no observable deficiencies. The mechanical devices appear to be secured in a manner to resist high wind events.

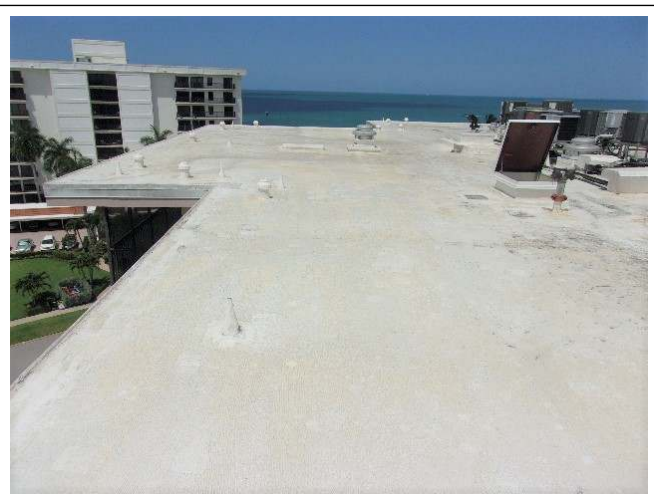
ROOF COVERING SYSTEM – The roof covering system is fully functional with no observable deficiencies. The mechanical devices appear to be secured in a manner to resist high wind events.

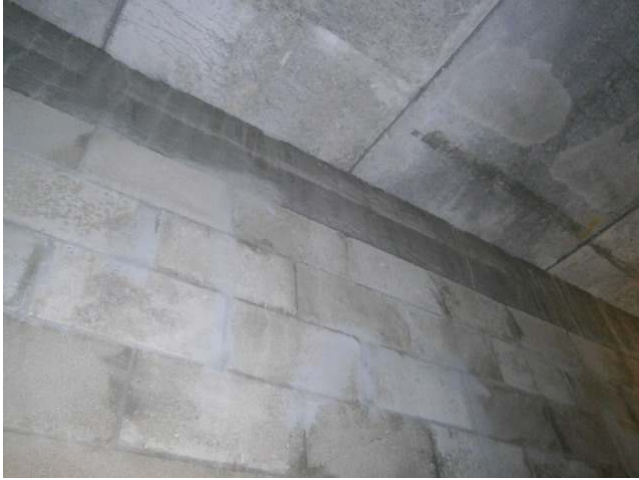
REINFORCED CONCRETE ROOF DECK ON
REINFORCED CONCRETE WALLS

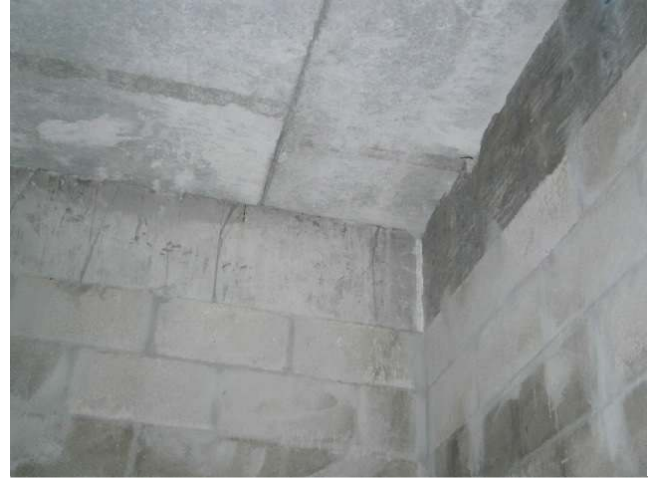
REINFORCED CONCRETE ROOF DECK ON
REINFORCED CONCRETE WALLS

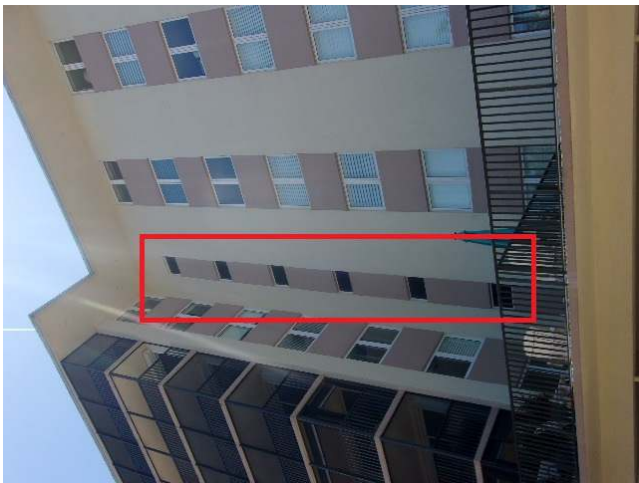
4. Opening Protection **N/A - Some glazed openings are not rated or protected**

OPENING PROTECTION – Although the unit owner window & sliding door openings are large missile rated, the stairwell windows are not rated or protected.

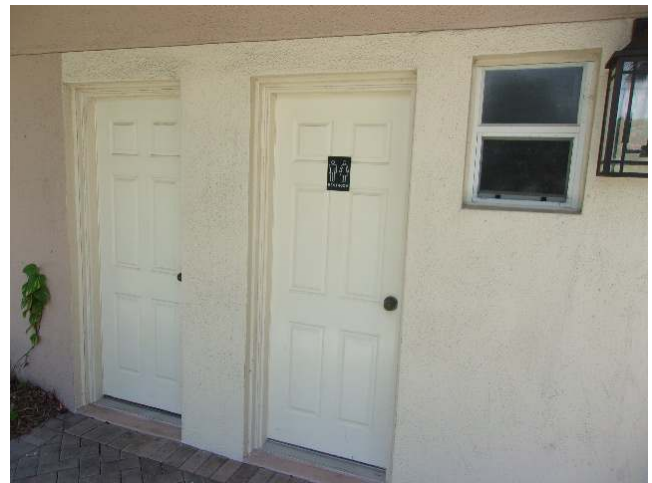
OPENING PROTECTION – The ground level pool bathroom doors are impact rated, but the window units are not rated or protected.

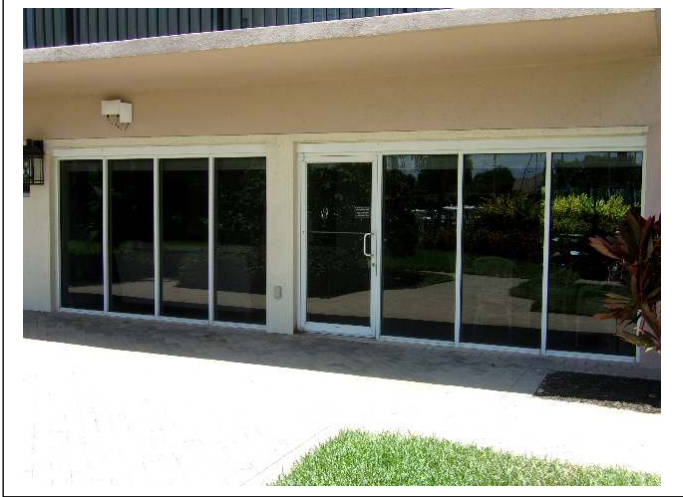
OPENING PROTECTION – The ground level glazed openings are not rated or protected.
